June 28, 2019
File No. 262018.063

Subject: Department of Natural Resources Washington Geological Survey,
School Seismic Safety Assessment Project, Contract No. AE 410 -
Seismic Evaluation for **Kelso School District**

1. Kelso, Carrolls Elementary School, Main Building

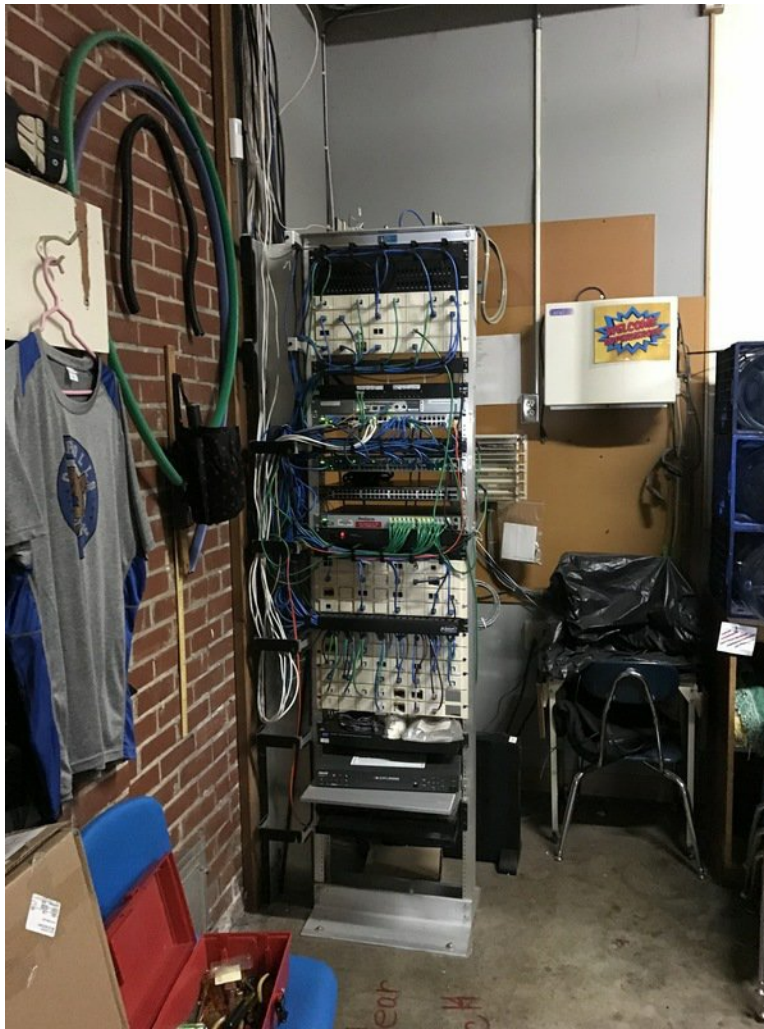
Figure 1-2. Server Rack

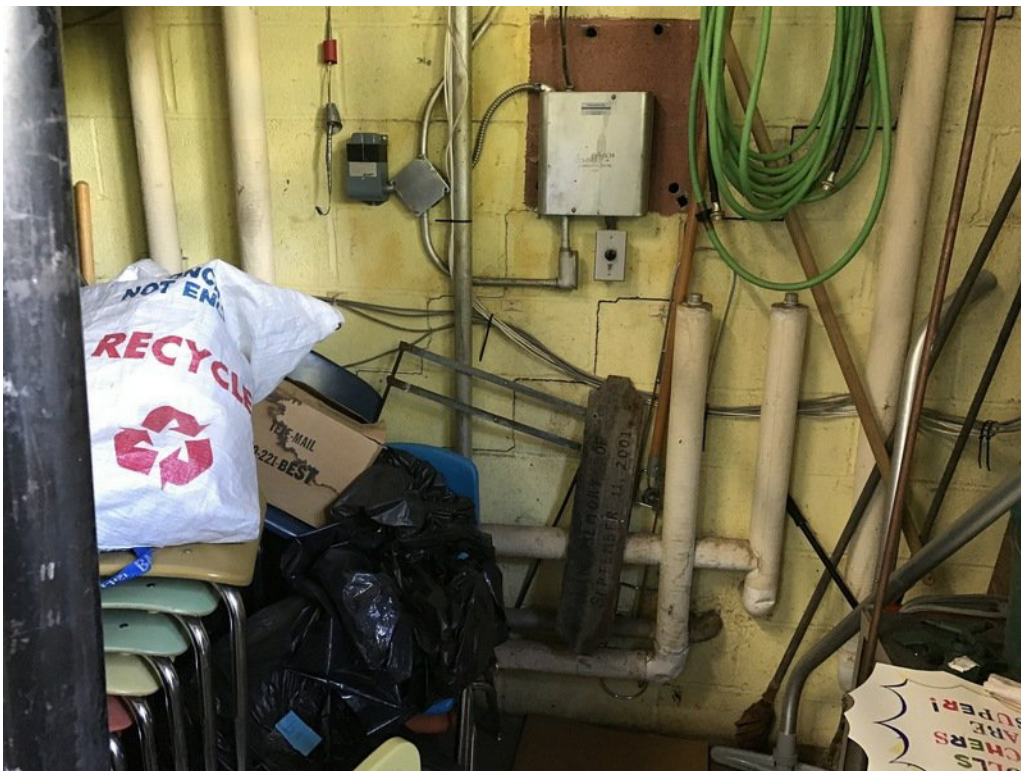
Structural System	Description
Structural Roof	No visible signs of corrosion, damage, or deterioration.
Structural Floor(s)	No visible signs of corrosion, damage, or deterioration.
Foundations	Unknown.
Gravity System	Several areas of light to moderate cracking of exterior masonry walls.
Lateral System	Several areas of light to moderate cracking of exterior masonry walls.

Figure 1-4. Cracks in CMU Wall, Typical

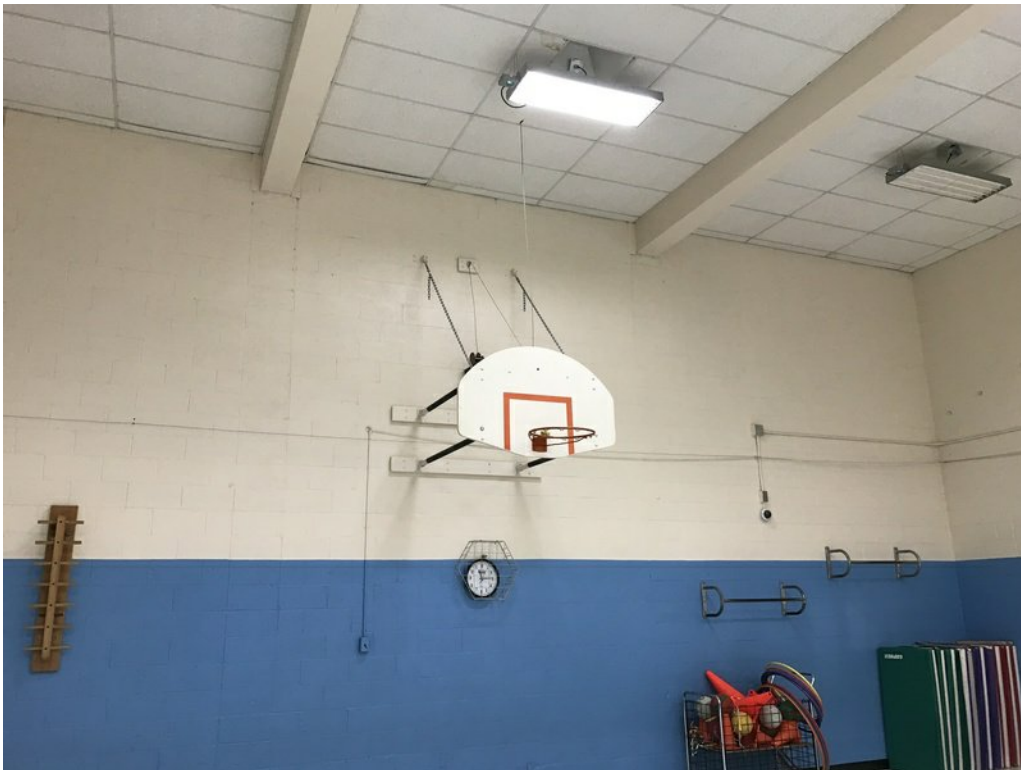
Figure 1-6. Gymnasium Roof Beams Supported by Pilasters

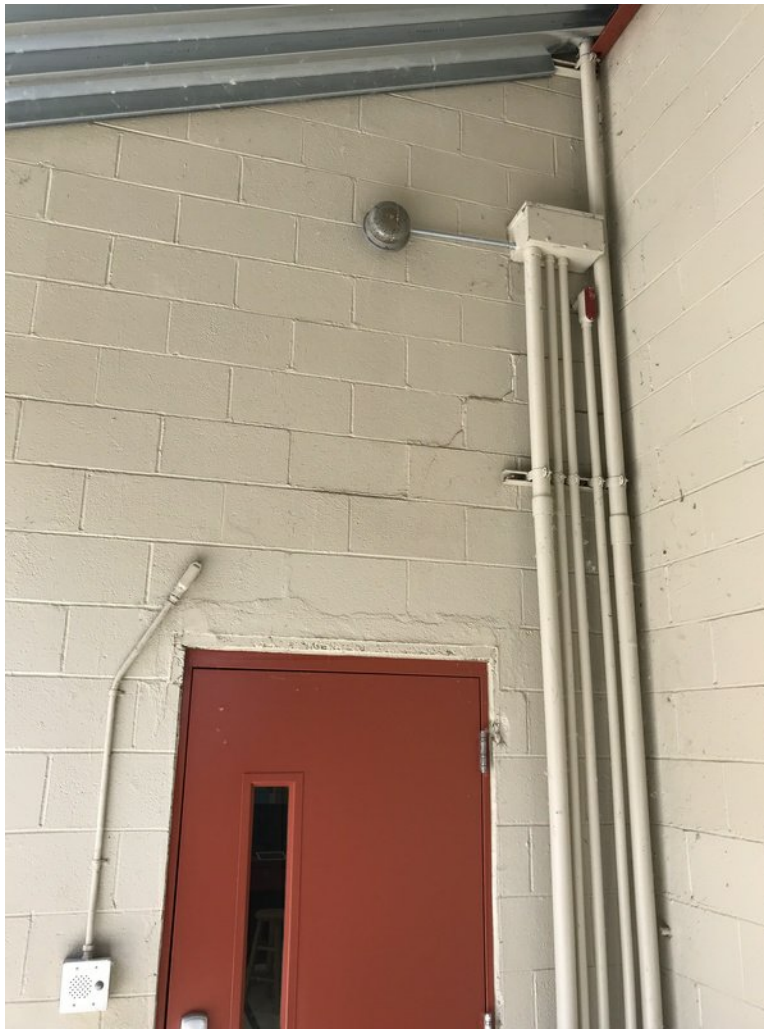
Figure 1-8. Cracking in Exterior CMU Walls
